UNDERWATER BRIDGE INSPECTION REPORT

STRUCTURE NO. 40508

1ST STREET

CANNON RIVER

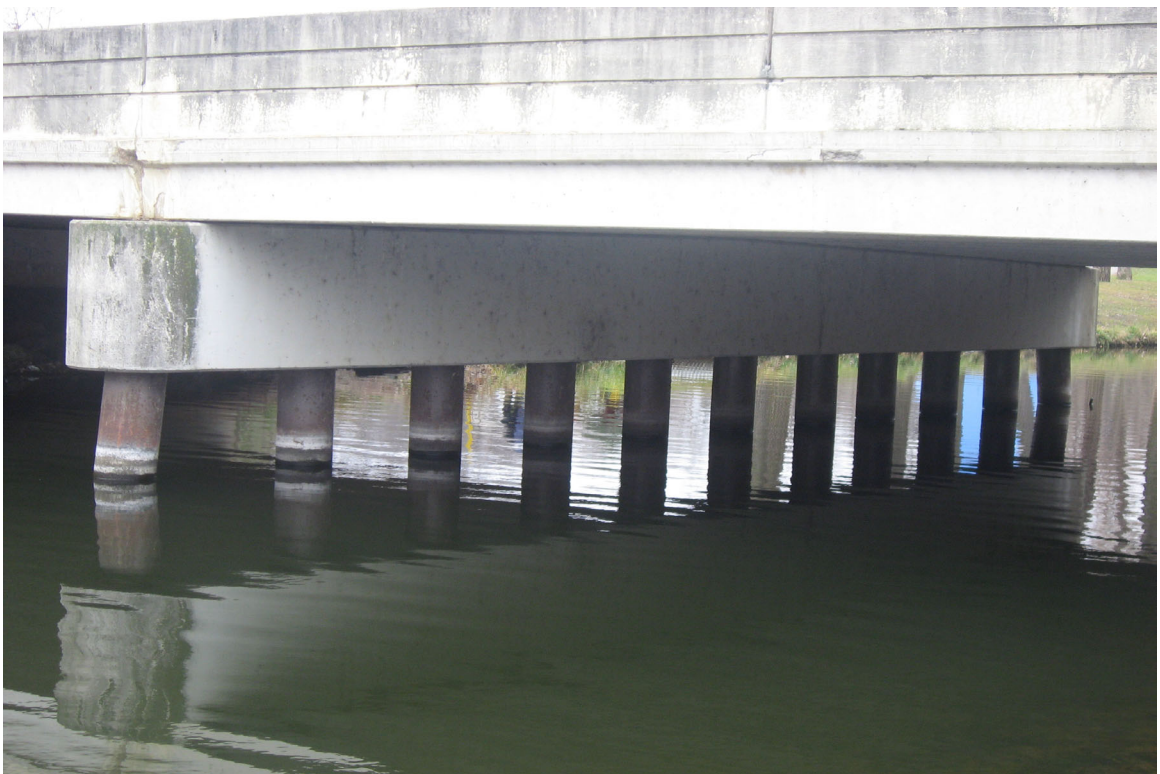
Photograph 2. View of Center Pier, Looking Southwest.

- (A) The steel piles from the waterline to the channel bottom exhibited 1/8 to 1/4 inch diameter rust nodules over 10 percent of surface area, and 50 percent of coating loss and pitting (minimal with less than 1/32 inch depth) from bottom of the cap to channel bottom.

REMARKS: Overall, the submerged steel of the piles was in good condition with no significant deterioration. The steel piles from the waterline to the channel bottom exhibited 1/8 to 1/4 inch diameter rust nodules over 10 percent of surface area, and 50 percent of coating loss and pitting (minimal with up to 1/32 inch penetration) from bottom of the cap to channel bottom. No notable channel bottom deficiencies were encountered.

- (A) Reinspect the submerged substructure units at the normal maximum recommended (NBIS) interval of five (5) years.
